Laboratory Testing 2009

Weathering & Strength of Oyster Baskets

Report Date: 31/07/2009

BACKGROUND & TESTING

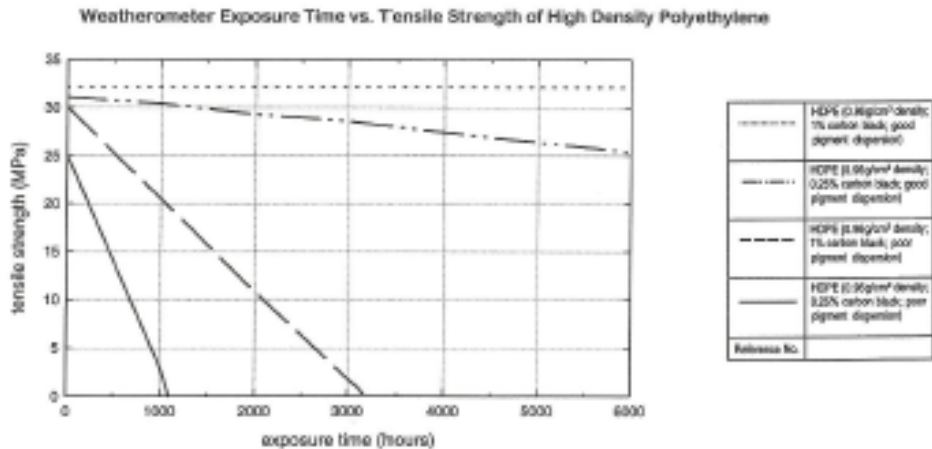
Figure 1: [redacted] Weathering (Effect of Pigment Loading & Dispersion)

(Source : The Effect of UV light & Weather – PDL Handbook Series, 2004)

2.5% is regarded as the saturation point for carbon black additions (no real benefit at higher loadings). 2.0% would be expected to give excellent performance. Blends with only 0.5% have been reported to undergo 10,000 [REDACTED] herometer with no change to tensile strength. Samples containing 1.5% carbon black have shown excellent results after 48 months outside exposure at the Florida weathering station (ref Table 1 on page 2). Figure 1 shows tensile strength retainment for HDPE blends containing between 0.25% & 1% carbon black. Good dispersion of the carbon black is a key to improved weathering performance, especially at low carbon black additions. This is not so important at levels of over 2.0%. Generally, it would be expected that the combination of injection moulded [REDACTED] + Superblak PE40/035 would show adequate carbon black dispersion.

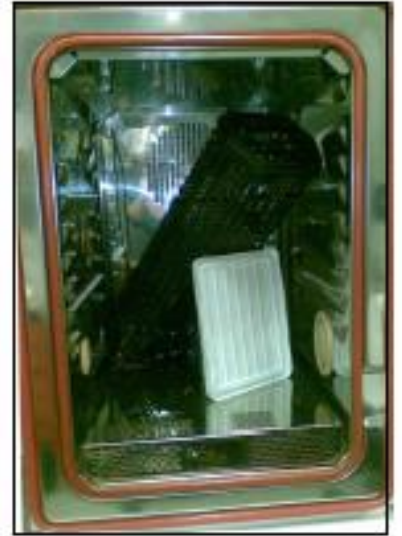
Photograph 1: Oyster Basket Positioned in Votsch Chamber and Supported Across Rib with Polypropylene Stand

Fully assembled parts were exposed in the Votsch Environmental Chamber, thermocycling between -20⁰C and +50⁰C for a total of 22.5 hours, followed by conditioning at 5⁰C for 1.5 hrs prior to drop testing. Details of the programme are given in Table 5 (refer page 5) and the test chamber set-up is shown in Photograph 1 (refer page 5). Due to the size of the assembled baskets, parts were required to be exposed individually, placed diagonally in the chamber and supported across the base of the basket using a polypropylene stand.

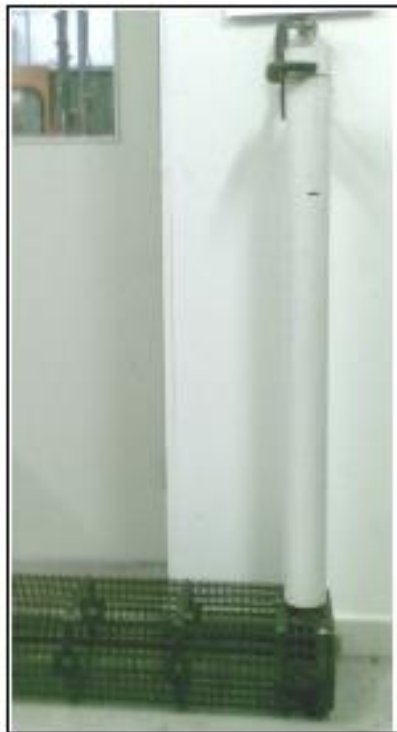
Photograph 1: Drop Tube Assembly

On completion of the exposure period, moulded parts were removed from the chamber and immediately dropped from a height of 1 metre onto a concrete floor. Parts were inspected for deformation or damage and then subjected to a falling weight, also from a height of 1 metre (see Photographs 2 and 3 (refer page 5)). Weights of 2.5 kg, 5 kg and 7.5 kg were used with each test site subjected to only one impact from a single weight. The test sites were selected from drawings supplied by Proen Design, illustrating the point of highest applied force being the rectangular area where the suspension clips are attached. Parts were again inspected for damage and results recorded.
